# Manhole Inspection Summary

## Manhole # S31CC\_009MH

Insp Date: **10/30/08 11:02 AM**

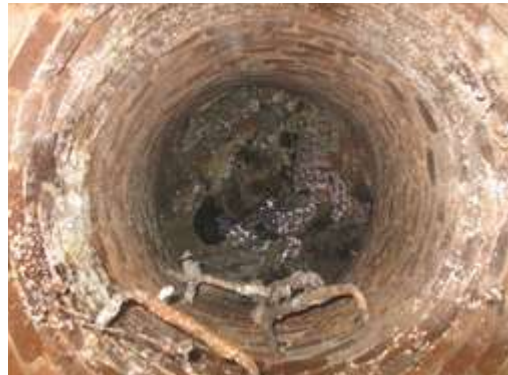
Top View

Needs cleaning - 1st visit.

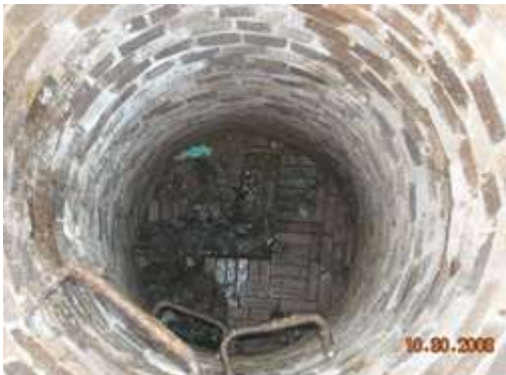
Top View

Corroded steps. Evidence of surcharge - Bench debris. Channel debris.

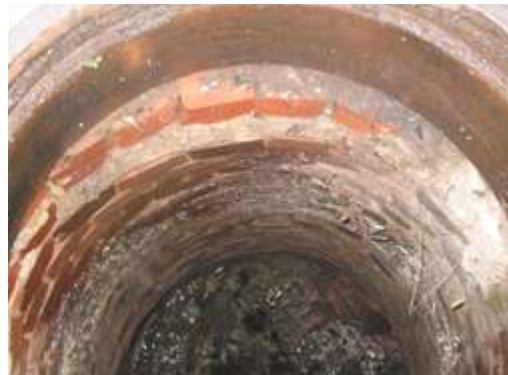
Defect

Frame leaks. Frame offset. Adjustment deterioration and infiltration. Corbel and Barrel infiltration.

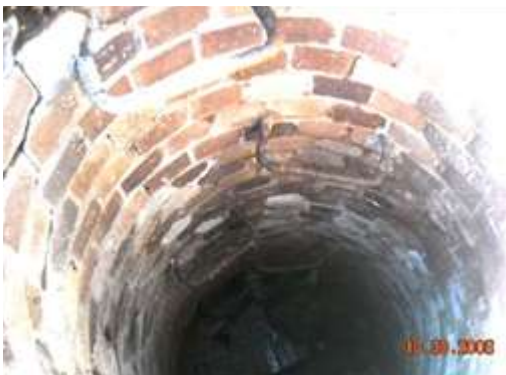
Defect

Adjustment deterioration and infiltration. Corbel and Barrel infiltration.

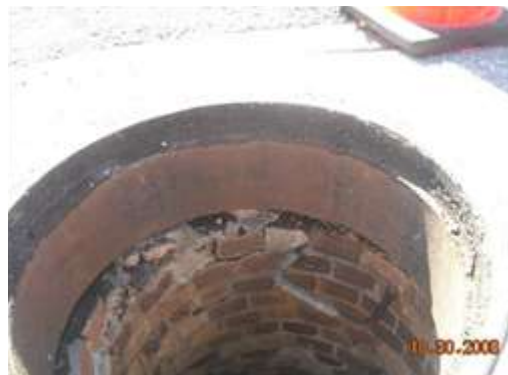
Defect

Frame leaks. Frame offset. Adjustment deterioration and infiltration.

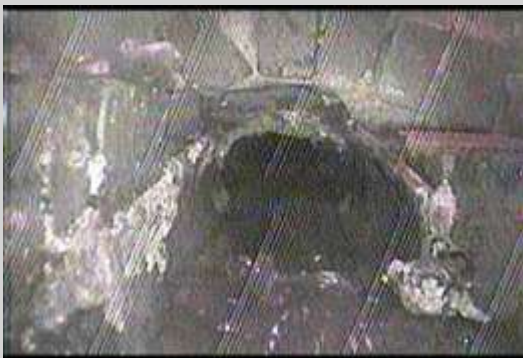
### 8 in. Circular Gravity Sewer Pipe In @ 9 O'Clock

Deposits: ☐ None ☐ Mud ☐ Sludge ☒ Debris ☒ Grease

Silt Depth: **0** (in.) Deposits Extent: **Light**

Infiltration: **Evidence** Pipe Seal Cond: **Unknown**
